Lead Based Paint Removal from Asbestos/Steel- walled Crane at the Panama Canal

Project 790

- Panama Port Administration's "Titan Grove"
- Large floating crane used on the Panama Canal
- Steel and asbestos structure
- Abatement of 50 year old lead-based paint; to be prepped for new coating

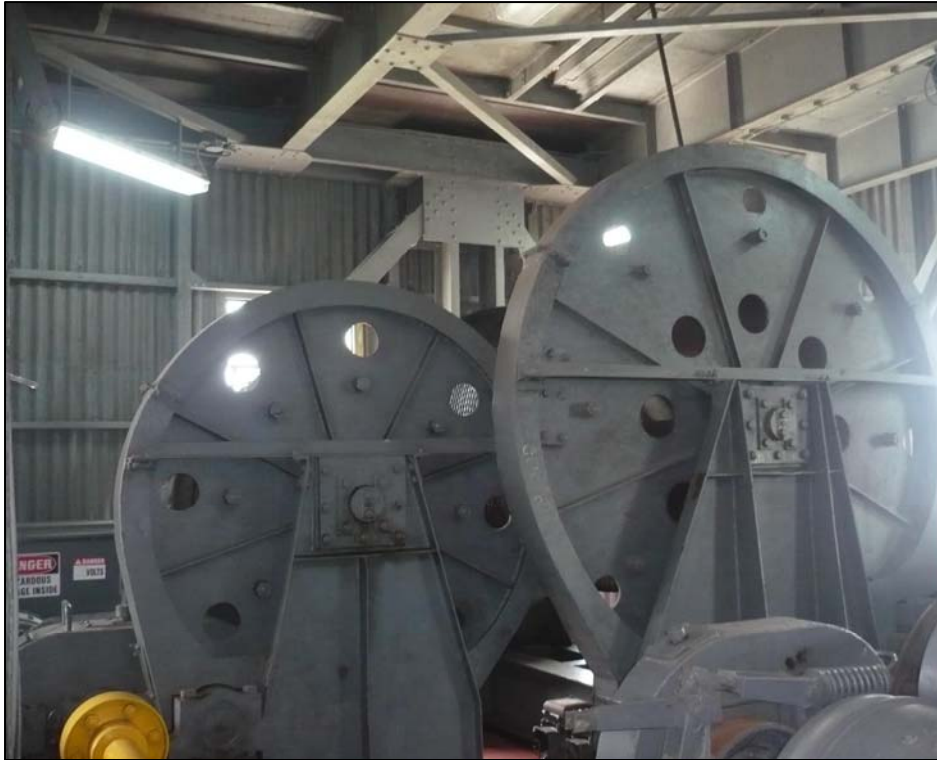
↑ Interior mechanism near
walls and beams

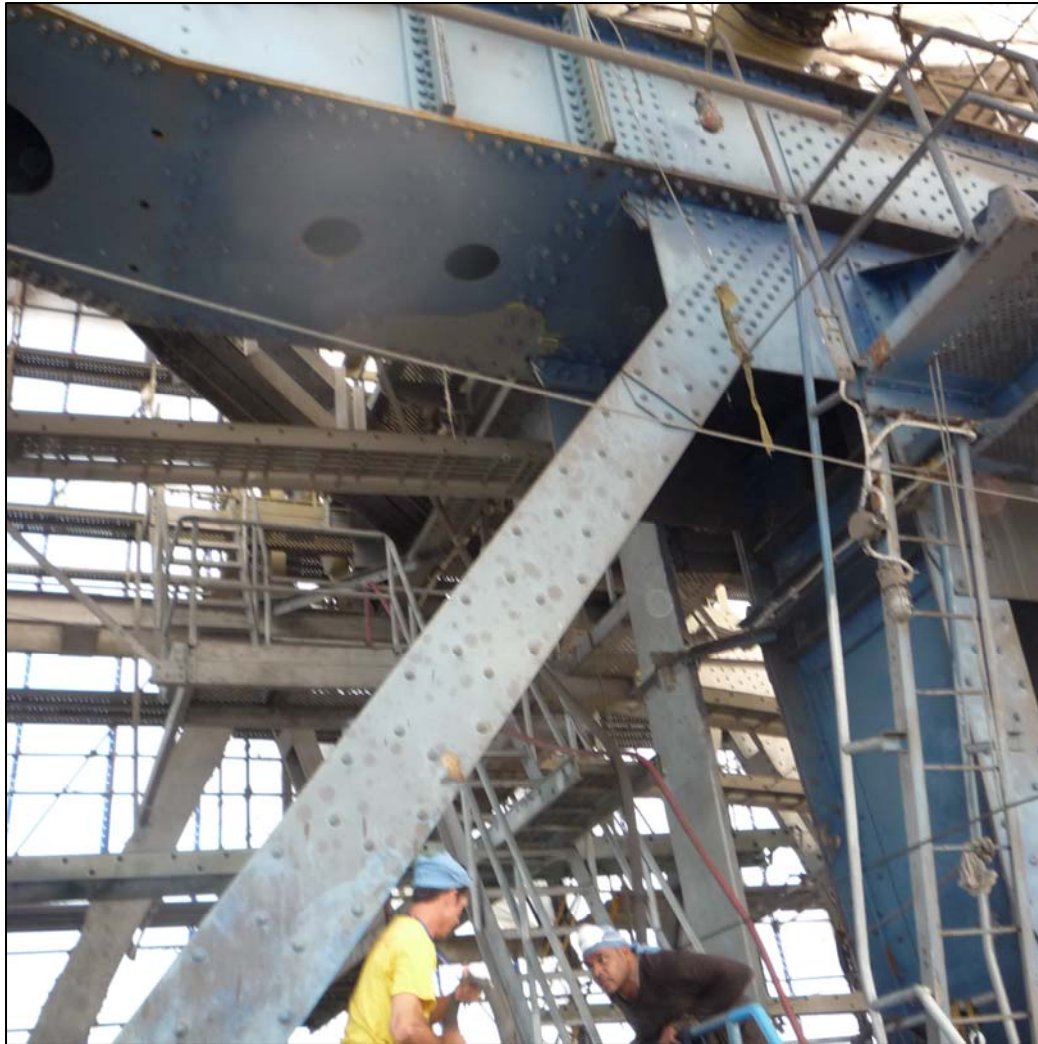
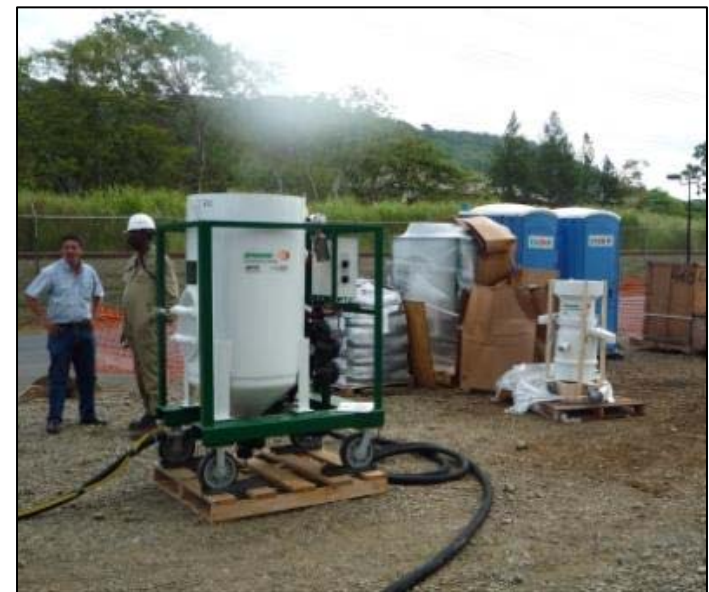
Used: Silver 30 Sponge Media™
abrasives (450 bags)

Two 400-HP Feed Units

35-P Recycler

Removal Rate:

128m² (1377ft²) per day

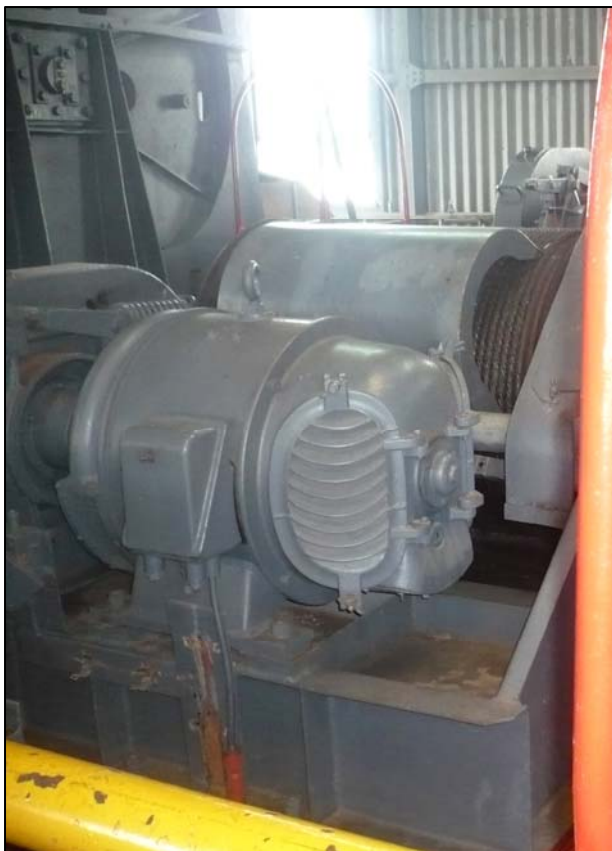
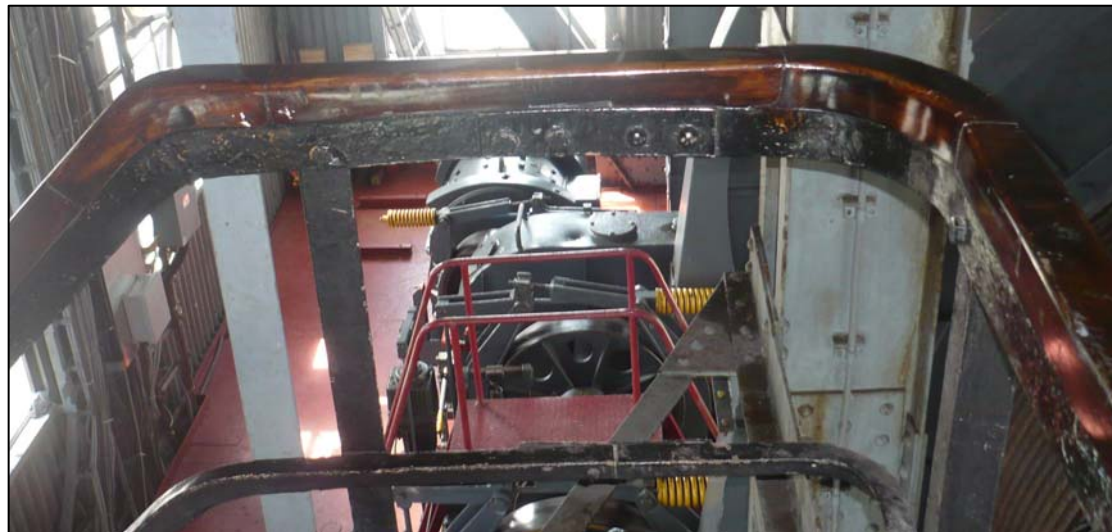
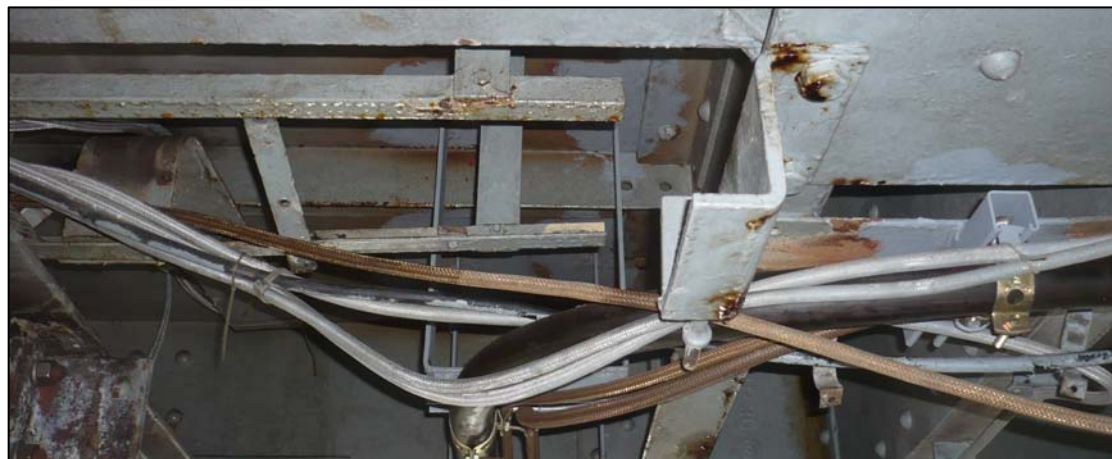
**Note surrounding
sensitive equipment**

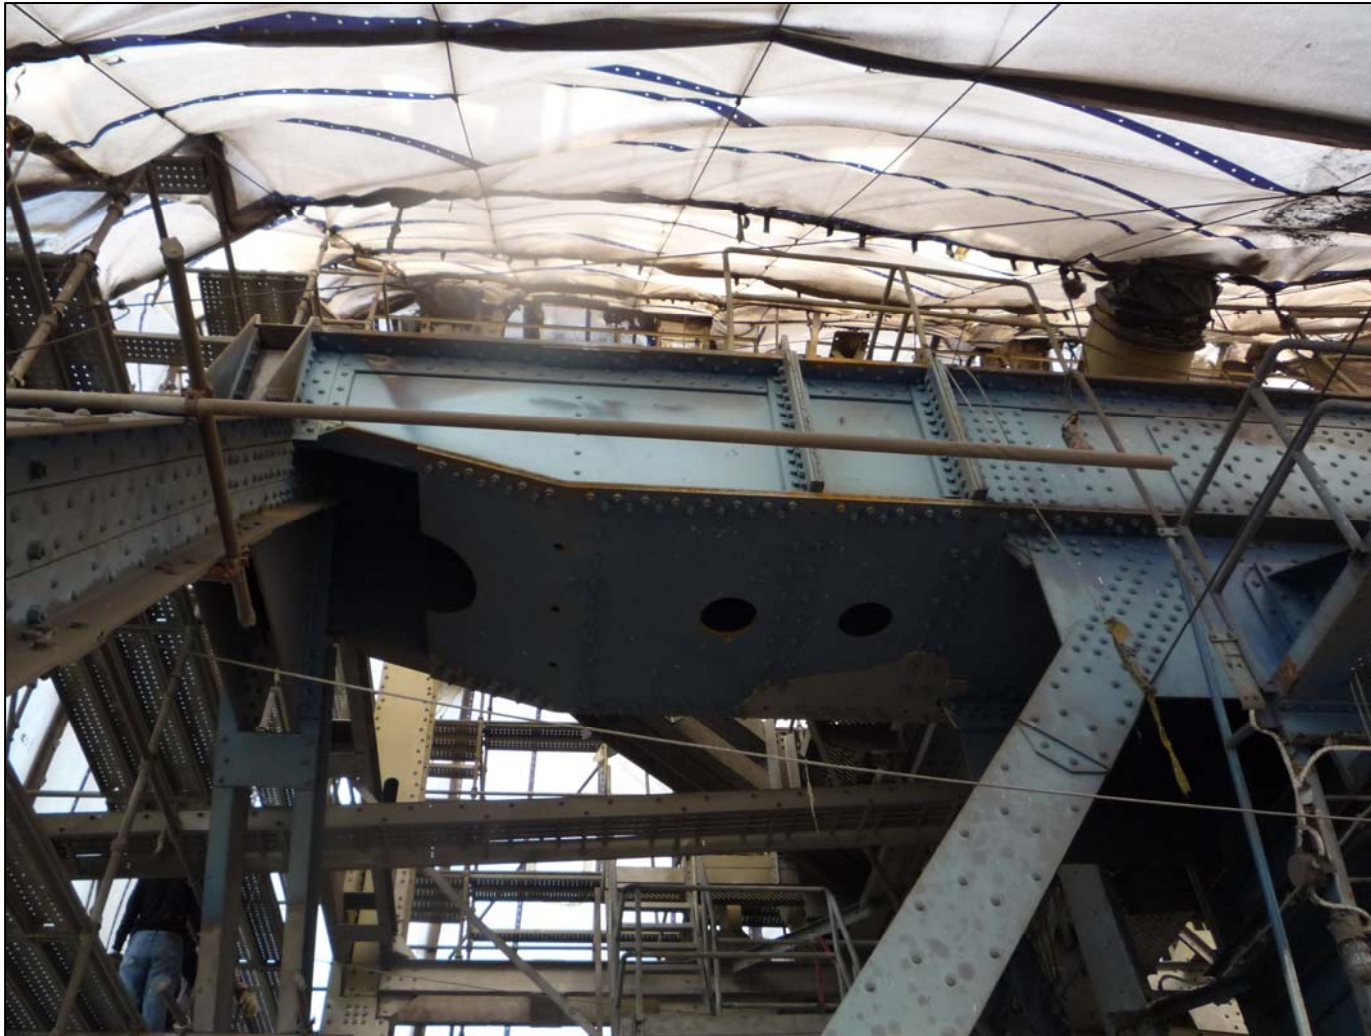
**Inside
containment**
